Manhole Inspection Summary

Manhole # S31A__023MH

Insp Date: **1/23/08 2:31 PM**

Location Address: **BEHIND 325 N EUTAW**

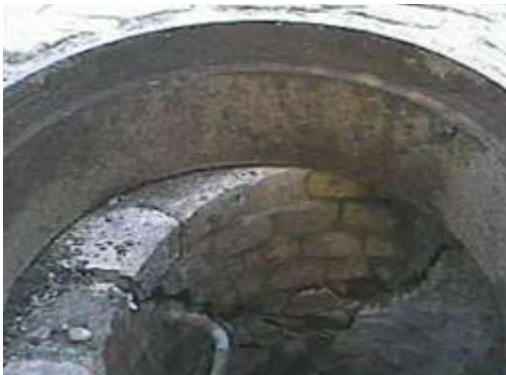
Defect 1

Condition: ☐ Sound ☐ Cracked ☐ Root Intrusion ☐ Loose Brick ☒ **Deteriorated**

deteriorated CORBEL

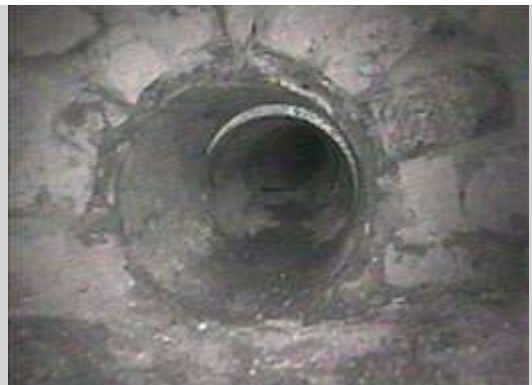
12 O'Clock Outflow

8 in. Circular Gravity Sewer
Pipe Out @ 12 O'Clock

MISALIGNED JOINT
